**DUTCHTOWN ROAD
FLOOD STUDY
REPORT
KNOX COUNTY, TENNESSEE**

**Ogden Environmental and Energy Services Co., Inc.
3800 Ezell Road, Suite 100
Nashville, Tennessee 37211**

May 7, 1999

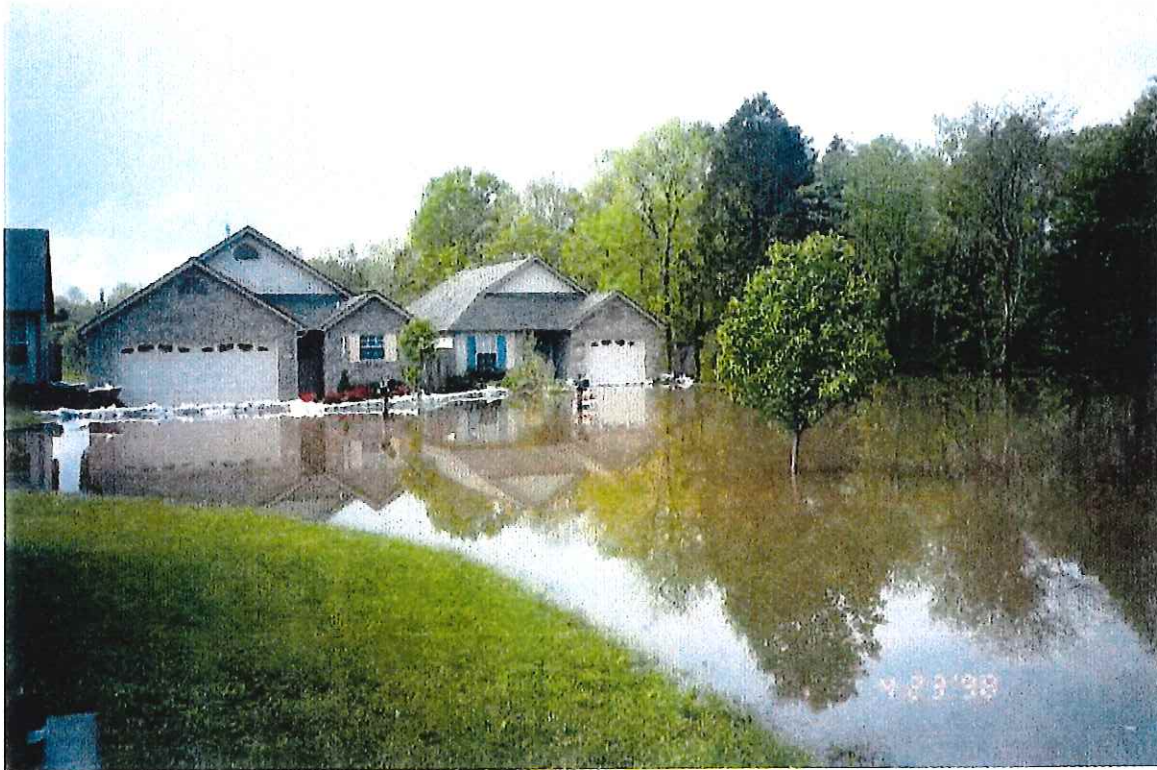
Figure 3. Dutchtown Harbor on Thursday, April 23, 1998.

The most severe flooding resulting from the April 1998 storm event occurred where Dutchtown Road crosses the Sinkhole DS7. Sinks DS7, DN1, and DN2 were filled to capacity (approximately 940.0 ft in elevation) after the storm. Flooding of Dutchtown Road and the entrance drive to the Dutchtown Harbor Condominiums began on April 19 and slowly rose to a high water mark elevation of 940.47 on April 21. Floodwaters did not recede quickly, and the road remained impassable until late May. Many backyards and small storage buildings at houses on Sarasota Road were flooded and sandbag dams were constructed around several condominiums bordering the DS7 Sink at the Dutchtown Harbor community (Figure 3).

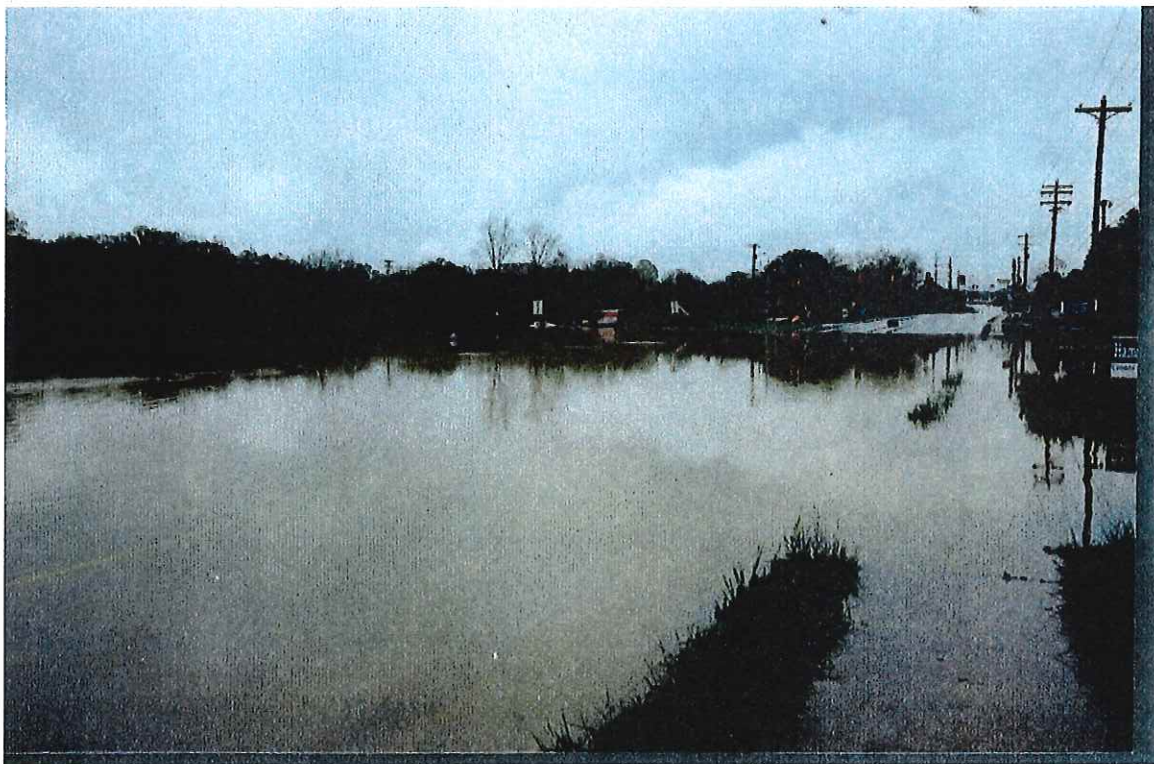
**Figure 4. Looking South on Cedar Bluff Road near Fox Lonas Road,
Sunday, April 19, 1998.**

Figure A-1 shows flooding at two locations in the Cedar Bluff Road Area. Cedar Bluff Road, Fox Lonas Road and Pensacola Road were all closed for several days when floodwater rose to an elevation of 931.8 ft in that area. Resident interviews and field observations during the storm indicate that the stormwater drainage system for Cedar Bluff Road was overwhelmed during the storm causing inlets along Cedar Bluff to surcharge (Figure 4). In addition, depression CB9 flooded to an elevation of 949.6 ft. These factors resulted in runoff flowing south on Cedar Bluff Road flooding Sinkholes CB6, CB7 and ultimately CB4.

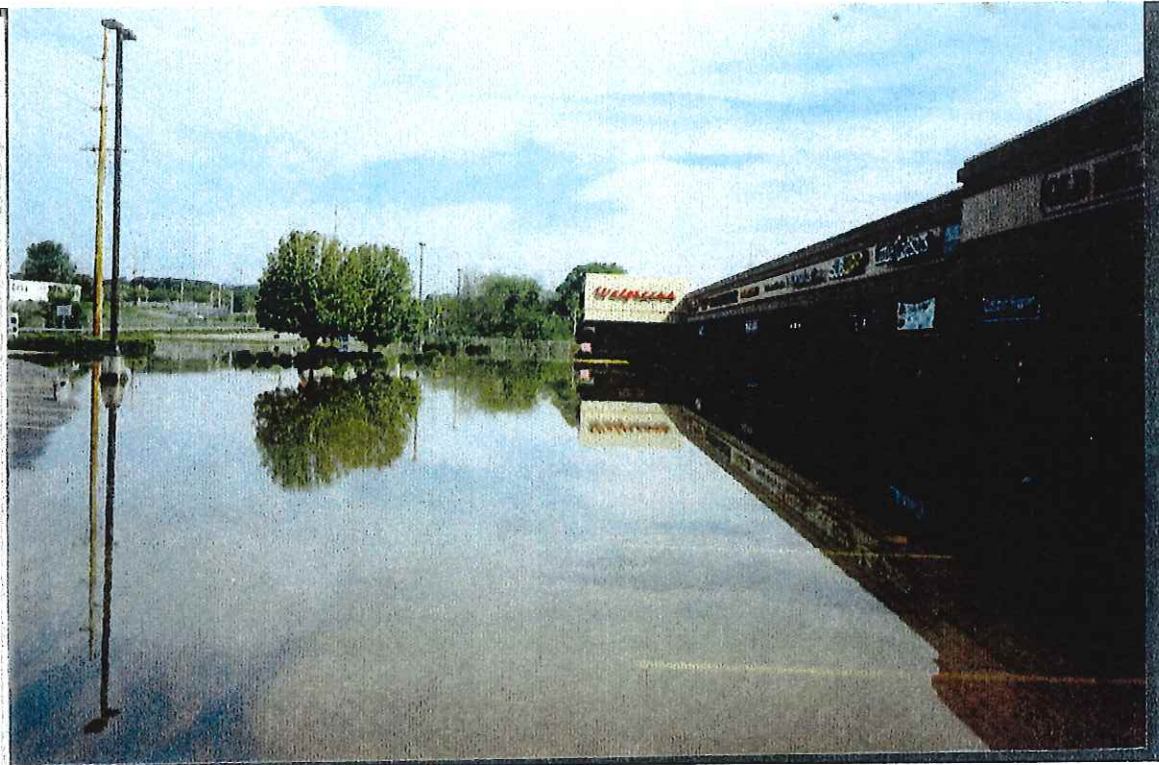
Figure 5. Walgreen's Parking Lot on Cedar Bluff Road, Sunday, April 19, 1998.

Sinkholes CB2 and CB3 also flooded during the event to an elevation of 935.7 ft. This caused the closure of Cedar Bluff Road and some flood damage in the Walgreens Drug Store located in the strip mall next to the CB2 Sink (Figure 5). Floodwaters in this area receded within several days of the event.
