Watershed Management Plan

The Turkey Creek Watershed Initiative

Town of Farragut, Knox County, City of Knoxville,
Tennessee

November 17, 2023

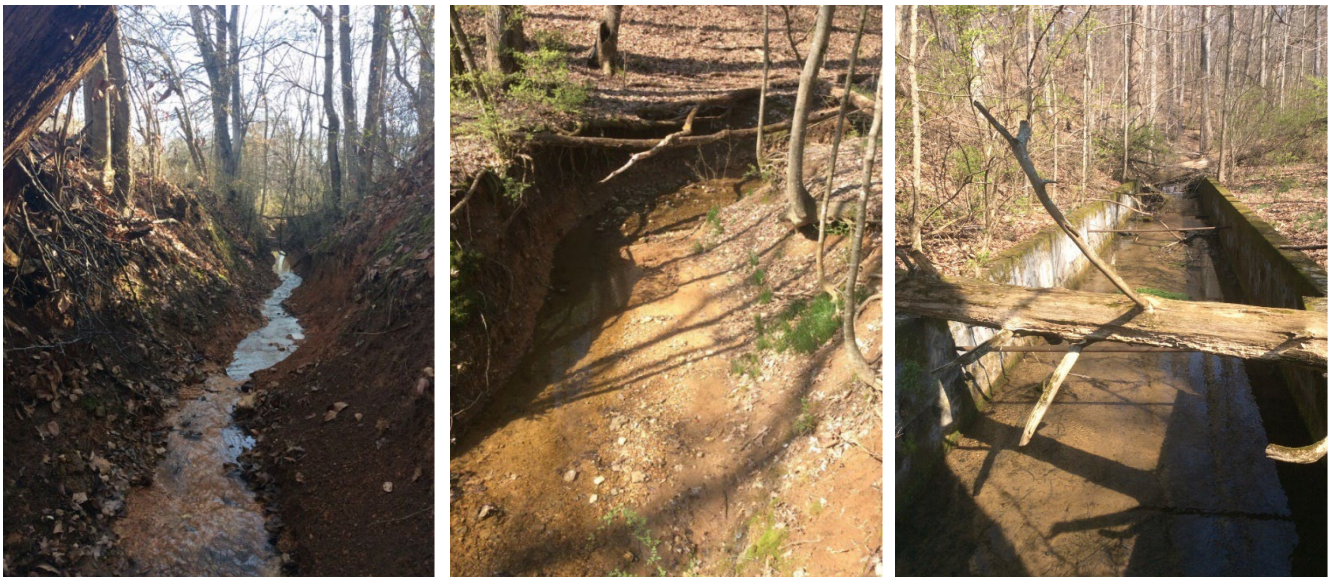
Figures 5-7. Examples of severe bank erosion and channel alteration in the headwaters of Turkey Creek.

The Town of Farragut and Knox County completed visual stream assessments (VSAs) between 2016 and 2019 using Center for Watershed Protection (CWP) Unified Stream Assessment methods modified to fit the needs of each municipality respectively. These assessments collected non-analytical data on impacted buffer and bank erosion. Between 2016 and 2019 the Town of Farragut assessed approximately 15.5 miles of creek in their jurisdiction and found 2.8 miles of inadequate buffer and 1.2 miles of severe bank erosion. In 2018 Knox County assessed approximately 9.3 miles of stream and found 7.5 miles of impacted buffer and 3.4 miles of severe bank erosion/channel alteration (Figures 5-7). Knox County assessed small tributaries in addition to the streams mapped by TDEC. The data collected here supports the cause of impairment listed by TDEC of “Loss of biological integrity due to sedimentation/siltation and alteration in stream-side or littoral vegetative covers”, and practices that reduce bank erosion and improve riparian cover are therefore considered in this plan.

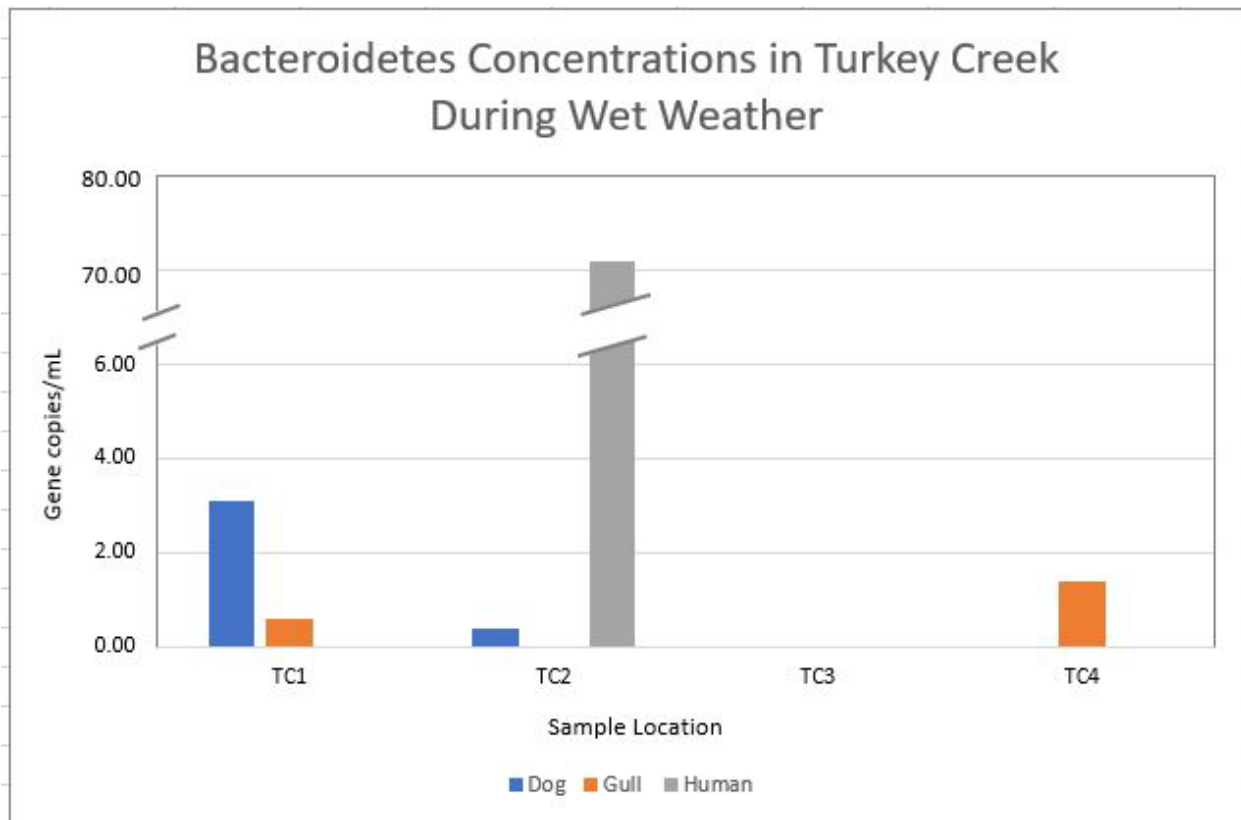
Figure 9. Bacteroidetes concentrations (gene copies/mL) at sampling locations in Turkey Creek during wet weather. It should be noted a scale break was made on the y-axis considering human Bacteroidetes concentration was much higher in TC2 in relation to other values on the graph.

The Town of Farragut conducted source tracking to determine if bacterial contamination was coming from humans or animals. Four sample locations were used, all residing in the Turkey Creek sub-watershed aside from TC2, which is in the North Fork Turkey Creek sub-watershed at Founders Park (Figure 8). Figure 9 below shows wet weather sampling results of Bacteroidetes concentrations that were above the least quantifiable limit. Human genetic markers can be confidently reported as present in TC2 with the result qualifier reported above the practical quantification limit. Human source contamination could be an indication of septic tank failure or sanitary sewer leaks. Given the presence of septic systems concentrated in the headwaters of North Fork Turkey Creek, efforts focused on promoting septic tank repairs should be concentrated in that sub-watershed. Also, given the presence of genetic markers from dogs at TC1 and TC2, education on proper pet waste disposal and installation of pet waste stations should be focused in those areas.

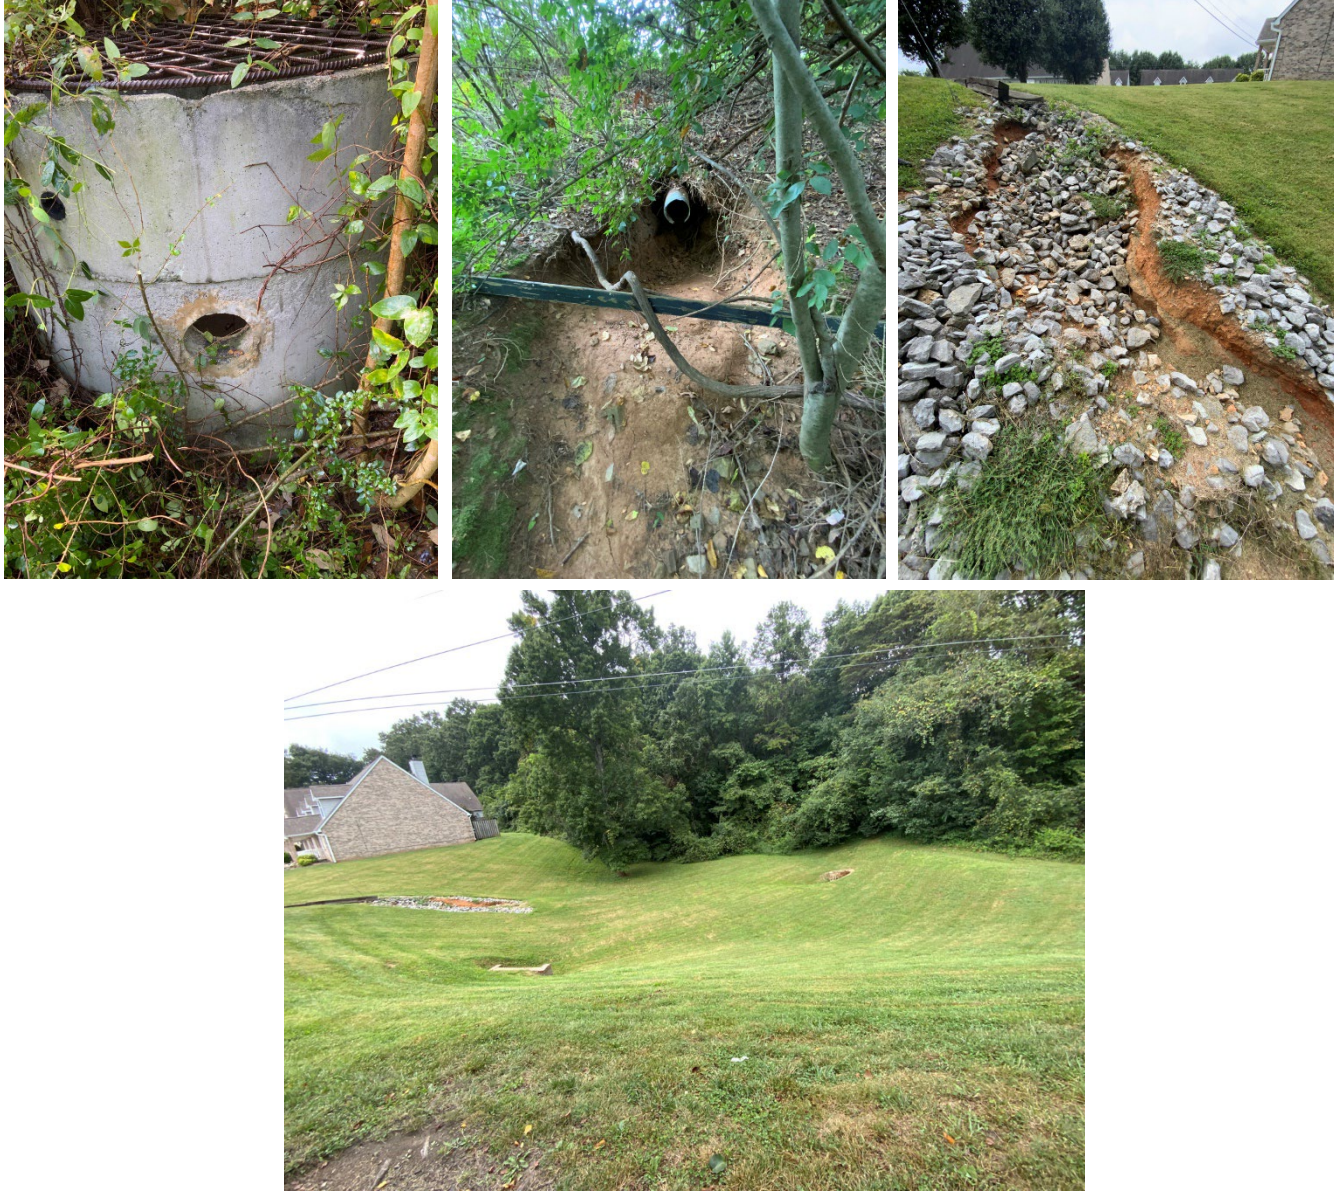
Figures 10-13. Examples of detention pond retrofit candidates in the Turkey Creek Watershed.

Many detention ponds throughout the watershed were constructed in older residential areas for stormwater volume control only, prior to newer (post- 2008) codes requiring water quality treatment. Nearly 120 detention ponds in the County and City were identified as potential retrofit candidates (examples in Figures 10-13). The intention is to assess these systems and retrofit the systems lacking water quality treatment and owner maintenance agreements. This will allow for stormwater to be retained longer and allow for settling of suspended solids and reduce the peak runoff to streams during smaller storm events. Additionally, it will ensure that older systems continue to be maintained to allow proper functionality. As peak flows are reduced in the stream, in-stream erosion is also reduced, further reducing sediment loads. This will overall reduce the amount of sediment entering the water bodies.
